St7a-MR: Mine Footprint and Reclaim, School Trust Fund, (Section 32, Hagen Township)

DNR 2c-RC (USFWS easement): Reclaim Depleted Zillmer Pit, DNR, (Section 1, Flowing Township)

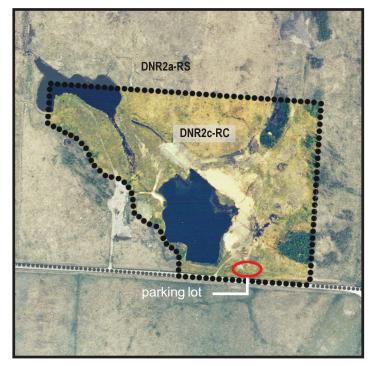
DNR2a-RS DNR2c-RC *#26 Drill holes 0 1-3 4-6 7-8 9-10

Small area of wet prairie on north side. Most of the area is disturbed and needs restoration.

Reclaim spoil piles and smooth slopes around pond where necessary for reseeding. Restore mesic and dry prairie vegetation. Continue reclamation work started by the stewardship committee.
